# INSTALLATION MANUAL: Faulty rotor batch 210 outer rotor system

Dear valued customer, we recently had a faulty batch of outer rotor flywheels. The magnets inside the rotor are polarised the wrong way around.

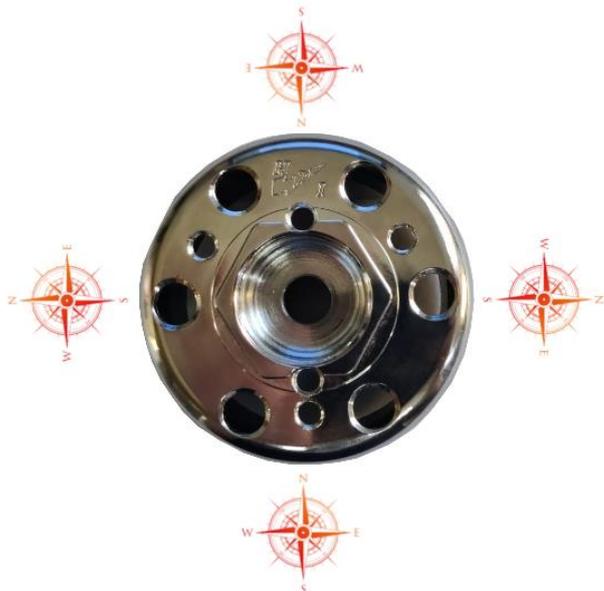
This picture shows a GOOD rotor, mind the HPI logo on the top. At the top of the rotor, the North pole of the compass is facing the rotor. At the bottom side, is also the North pole of the compass faces the rotor.

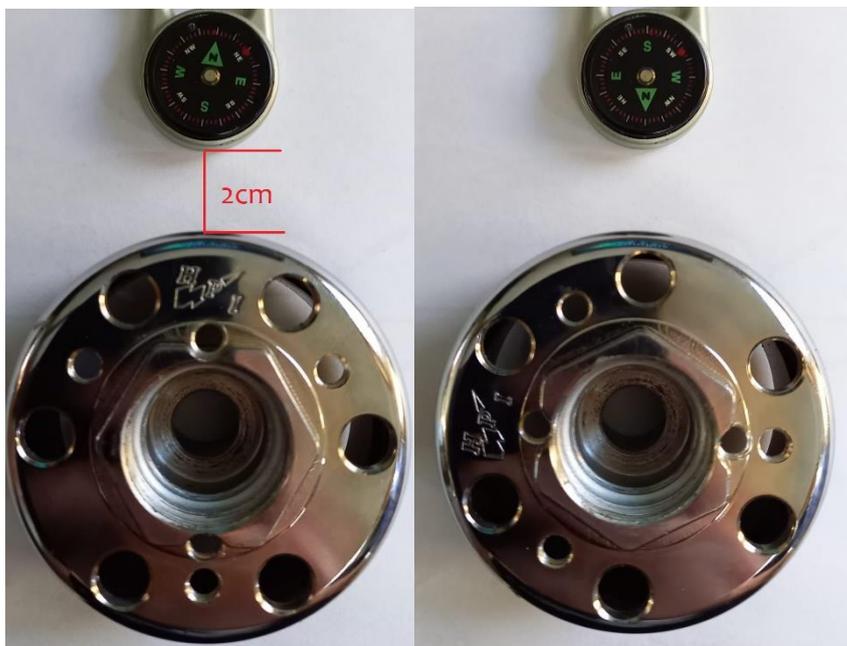
In a faulty rotor, the magnetic field is reversed. You can easily check with a compass.

If you've a WRONG rotor you will see this:

(check with compass and flywheel on the table)

If you have a faulty rotor, you can solve this problem by turning the rotor 90°
